GOODHUE COUNTY

PUBLIC WORKS FACILITY ASSESSMENT MASTERPLAN

COMMITTEE OF THE WHOLE PRESENTATION

September 16, 2025

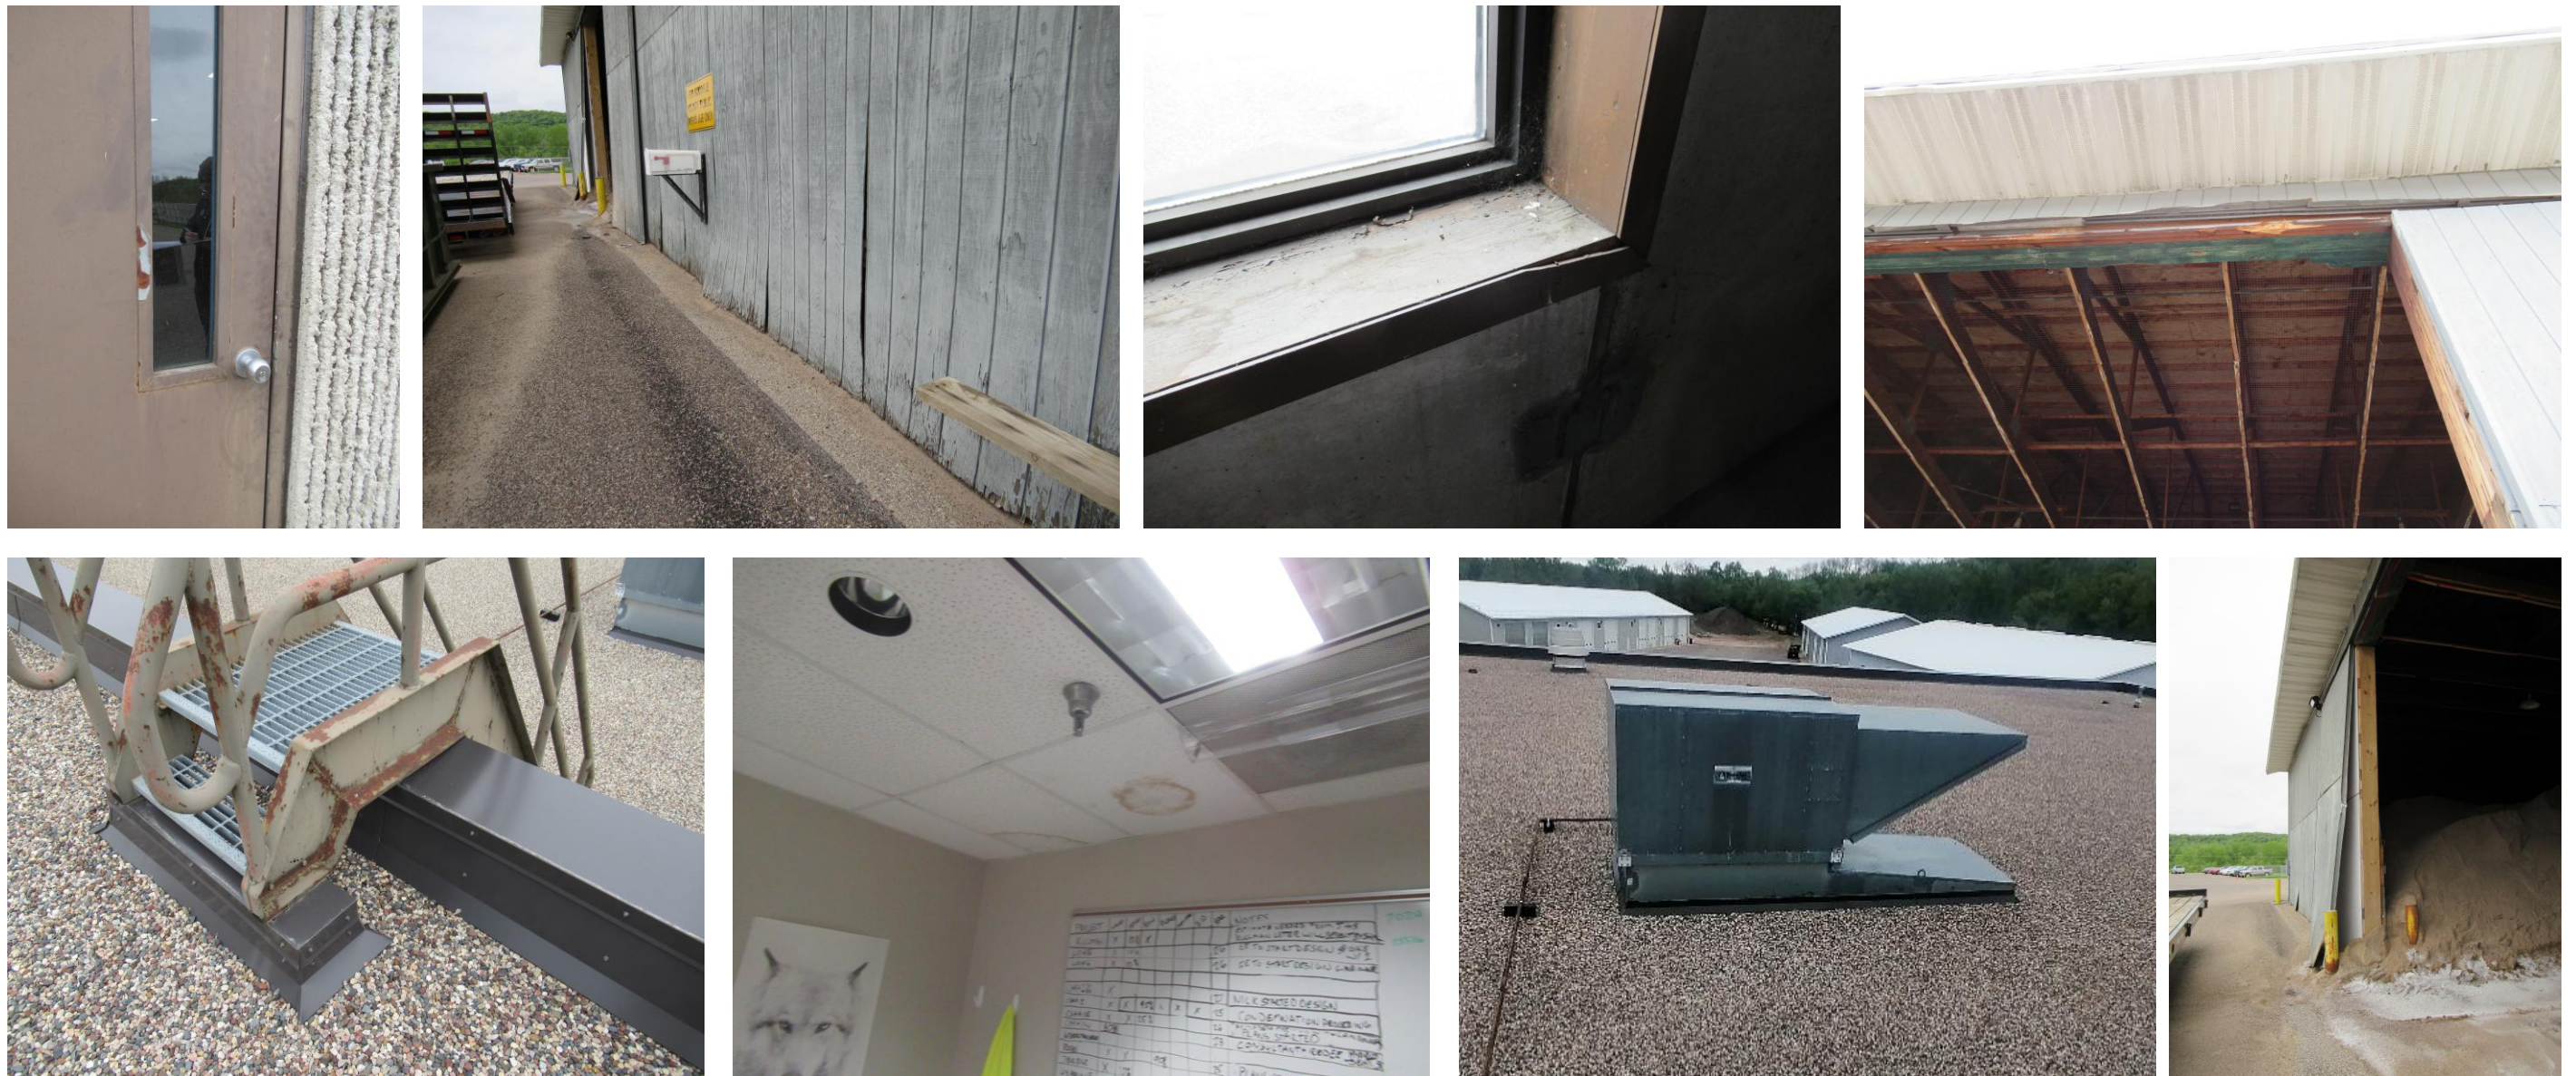
Salt Shed Replacement, Exterior Painting, Light Fixtures, Lighting Controls and Ceiling Tile Replacement, Replace Window Sill, Makeup Air Unit

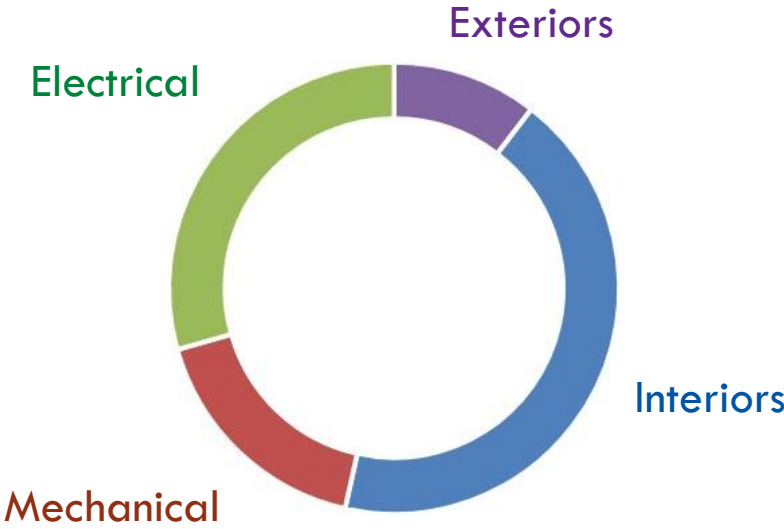
Immediate 0-4 years

Salt shed repairs or replacement
Painting doors and frames
Window sealant
Door levers
Ceiling tiles
Makeup air unit
LED fixtures and lighting control

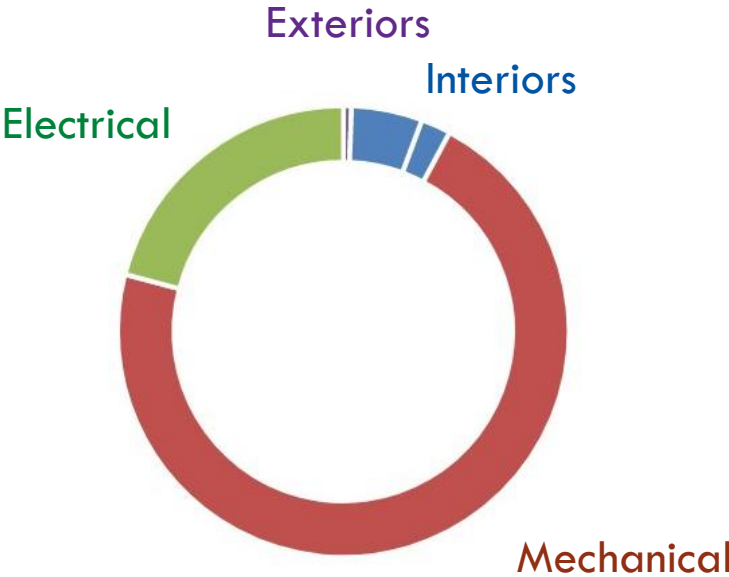
Intermediate 5-10 years

Repair concrete curbing
Partial floor slab replacement
HVAC zone plan and duct modifications
Restroom modifications
Exhaust fans
Air compressor
Electrical panel board/switch board
Emergency generator

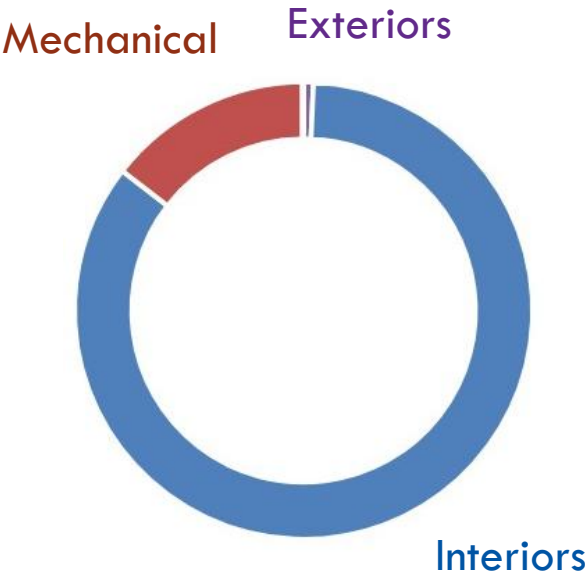
Long Term 10-20 years

Office renovations
(walls/doors/finishes)
Mechanical rooftop units
Fire suppression system

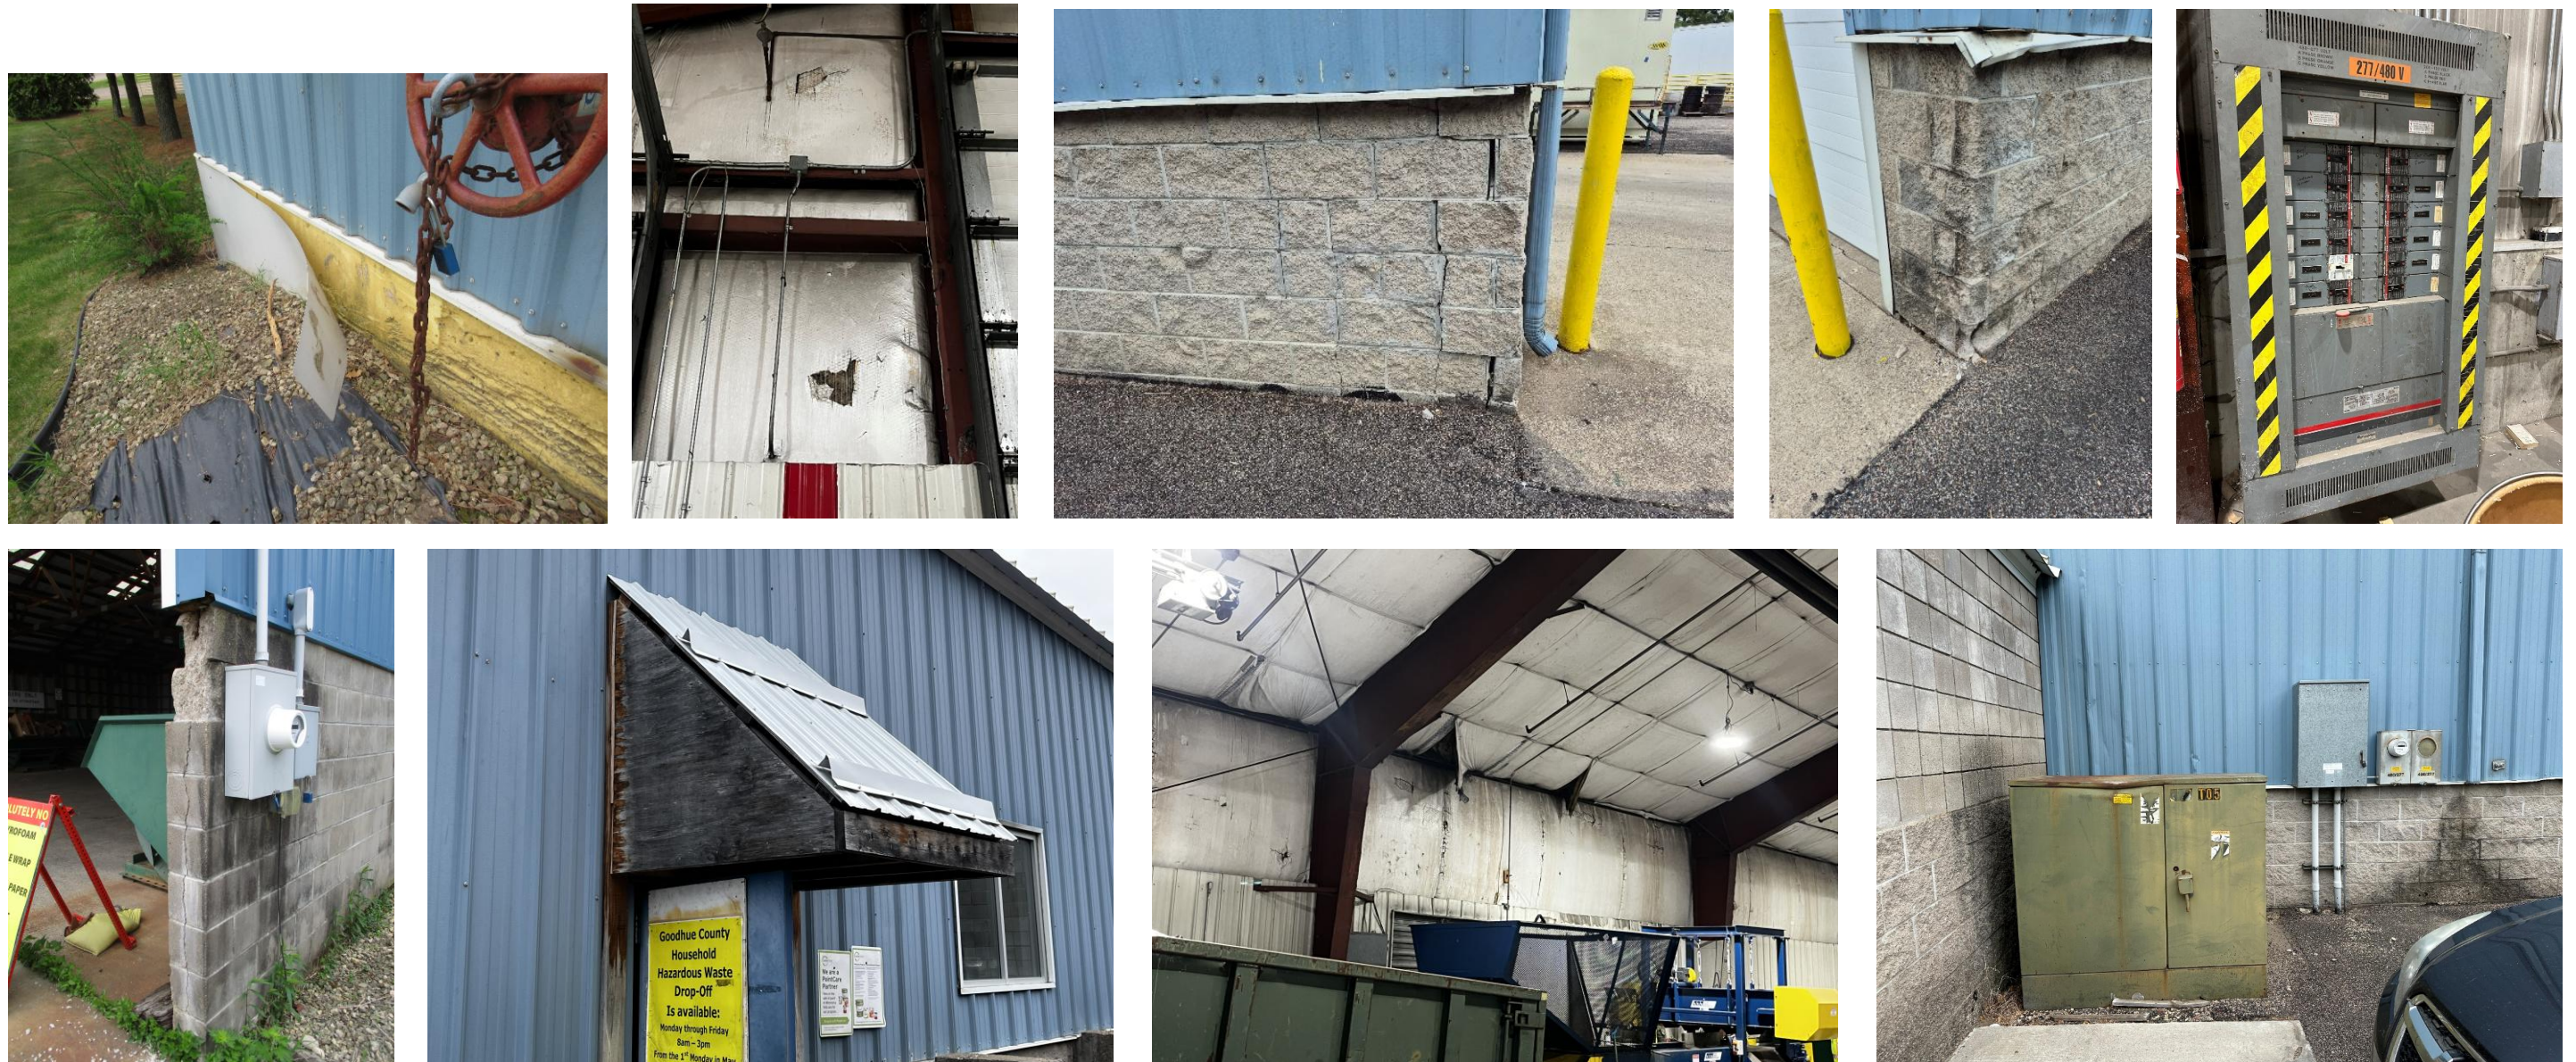
Exterior Painting, concrete slab, exterior repairs, exterior masonry repairs, interior insulation, HVAC system, electrical panel

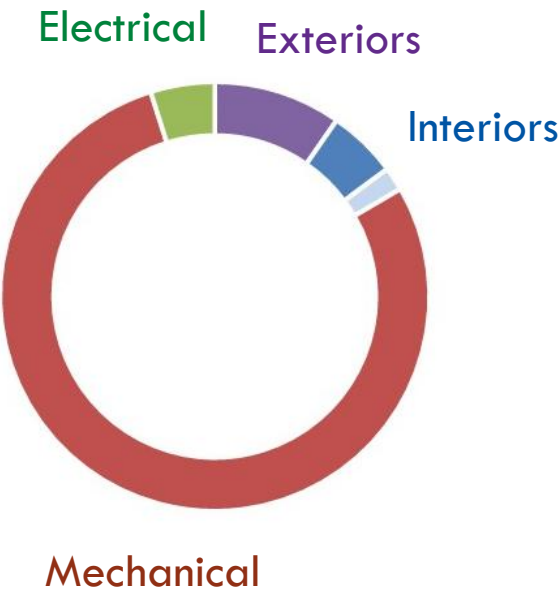
Immediate
0-4 years

- Repair CMU wall base
- Sealant
- Repair torn insulation
- Repair wall paneling
- New ventilation system
- Light fixtures

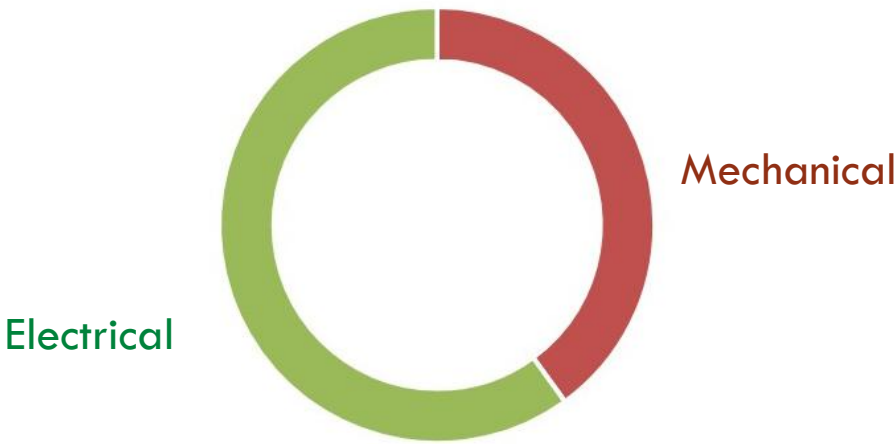
Intermediate
5-10 years

- Replace infrared heating system
- Waste trap
- Electrical service

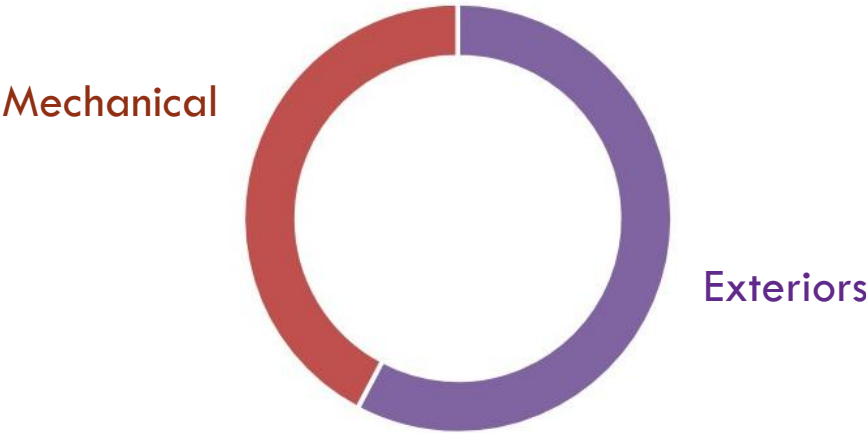
Long Term
10-20 years

- Exterior metal trim
- Air compressor

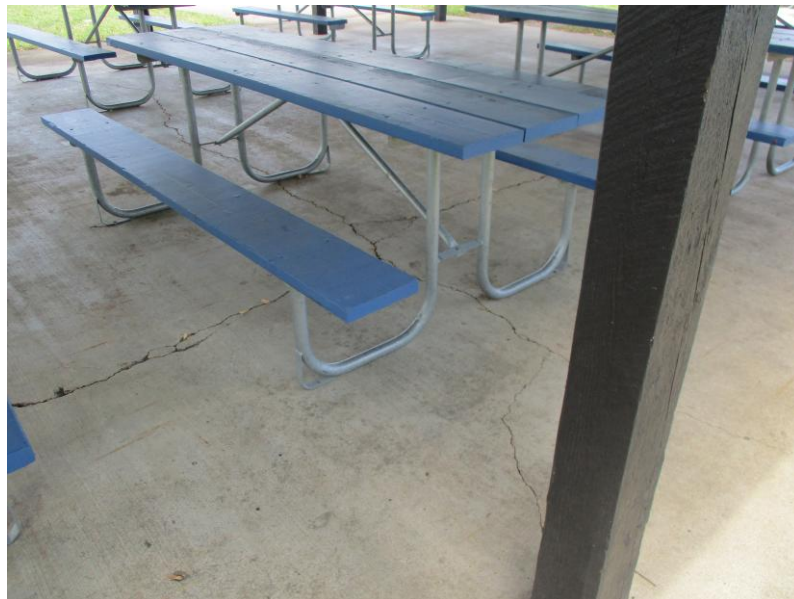
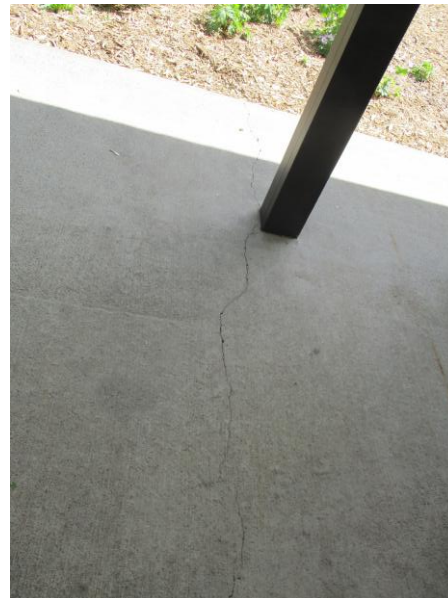
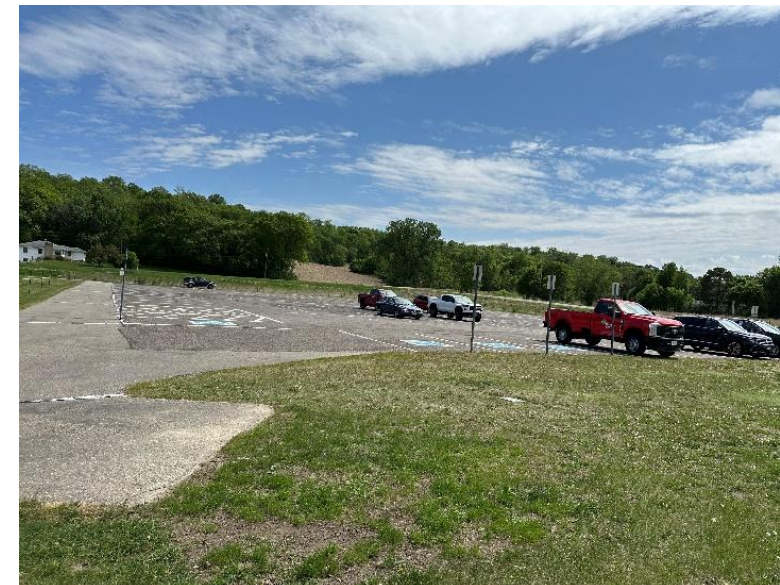
Concrete slab cracking, site lighting and security cameras

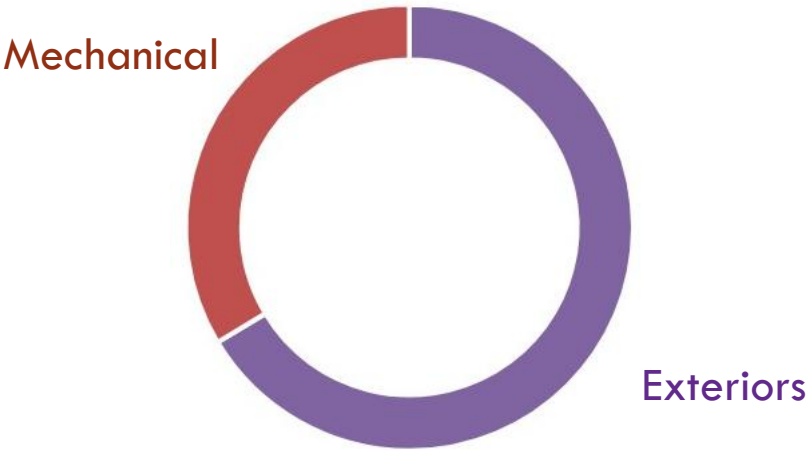
Immediate
0-4 years

Concrete slab crack repairs
Utility room heater

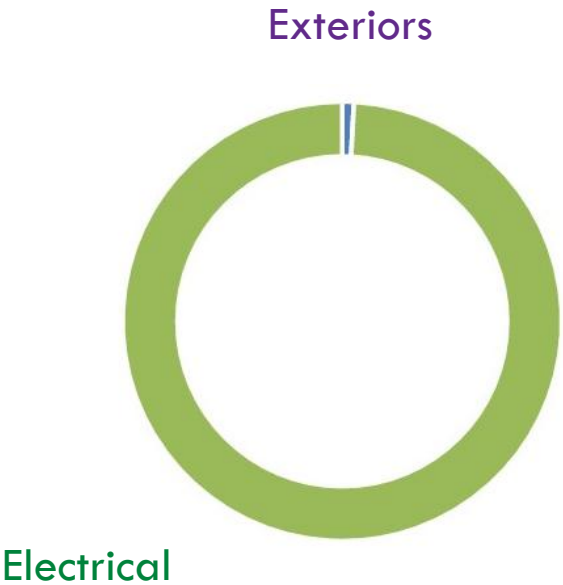
Intermediate
5-10 years

Concrete slab sealant
Site security lighting

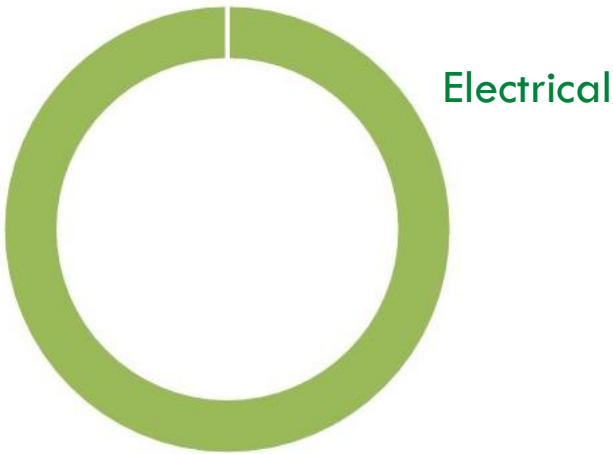
Long Term
10-20 years

Camera replacement

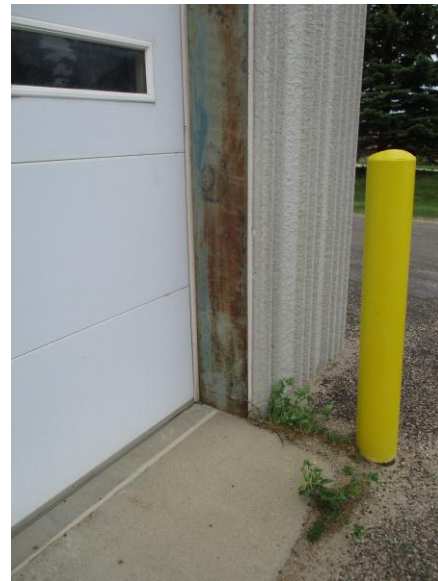
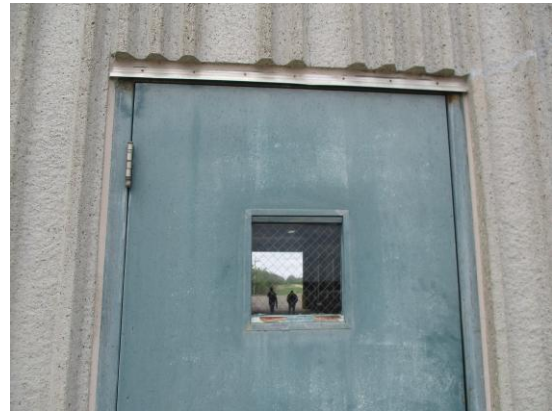
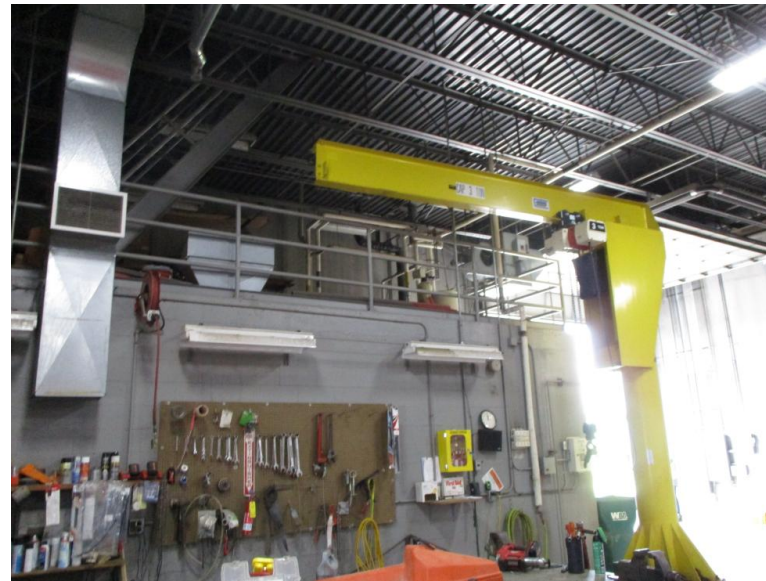
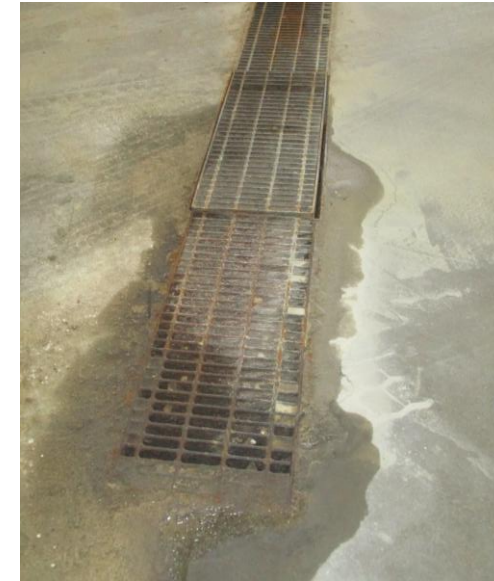
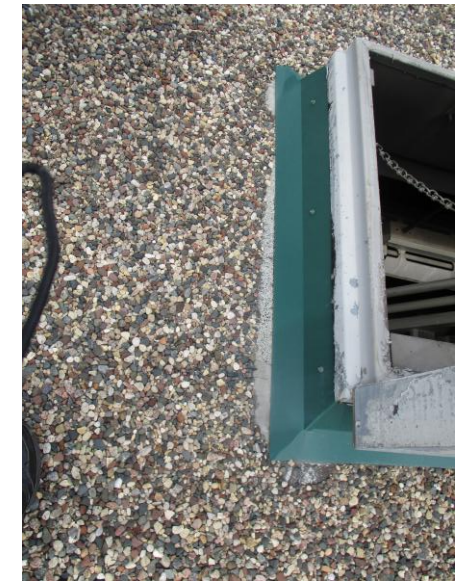
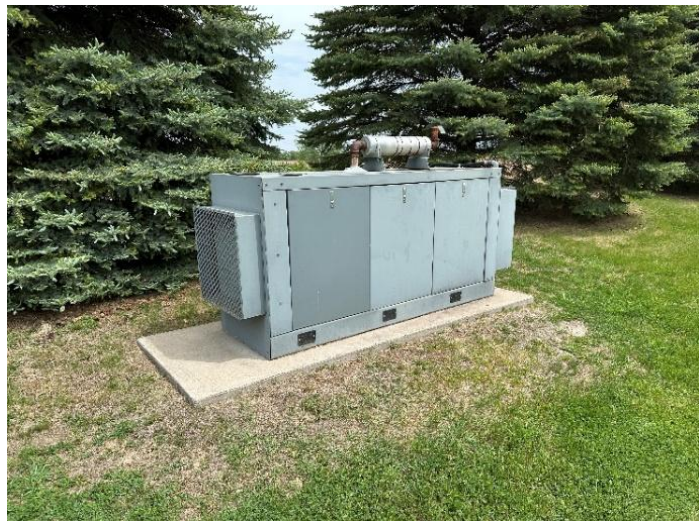
Exterior painting/sealant, generator, panel boards, fluorescent lighting, fire alarm panel, concrete slab cracking

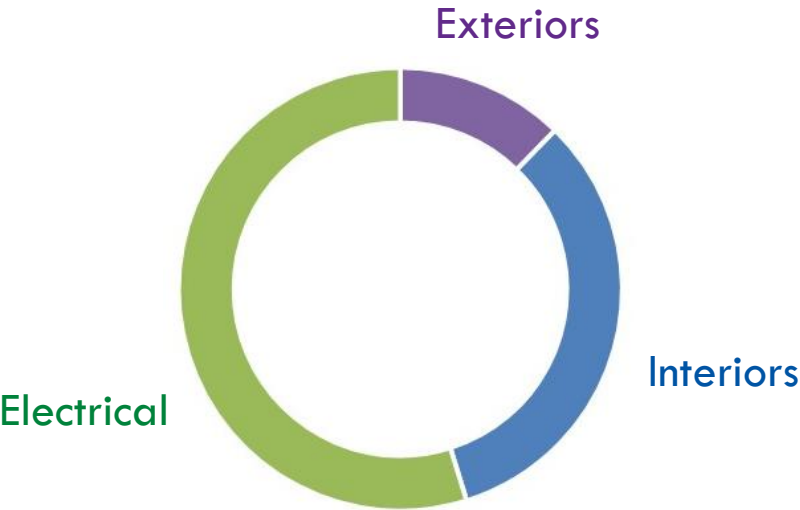
Immediate
0-4 years

- Paint
- Sealant
- Roof repairs and hatch guard
- Paving repairs
- Trench drain replacement
- Generator
- Lighting controls

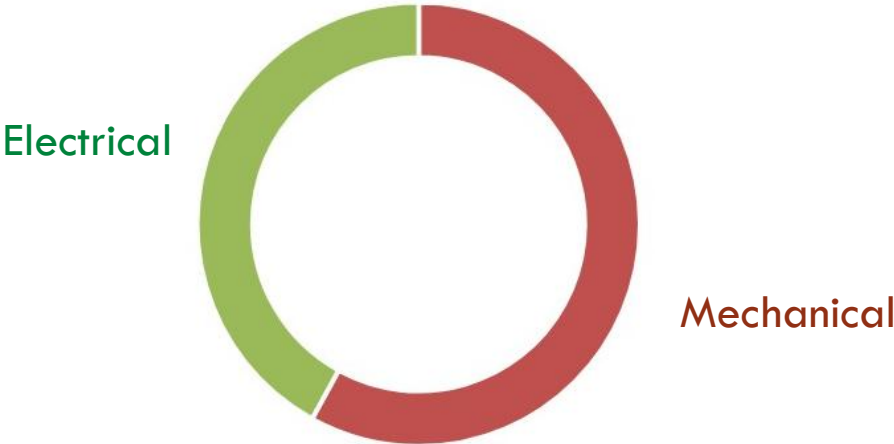
Intermediate
5-10 years

- Furnace
- LED Light fixtures
- Fire alarm panel

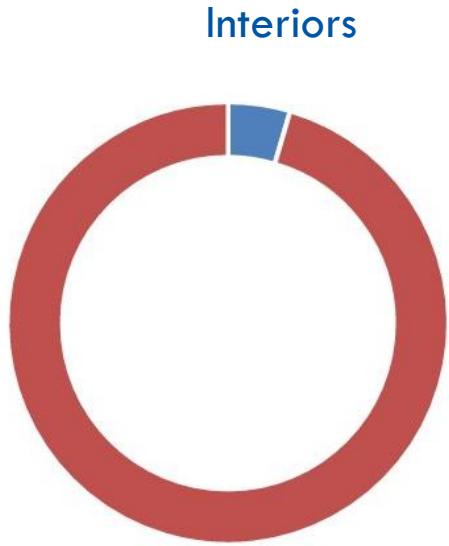
Long Term
10-20 years

- Truck entrance apron slab replacement
- Concrete slab replacement
- Add sand interceptor
- Add fire suppression system

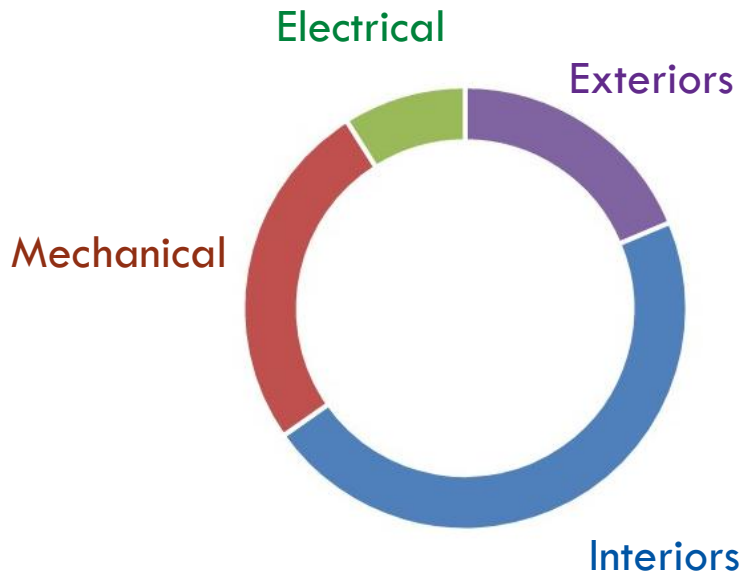
Immediate
0-4 years

Paint
Guardrail at roof hatch
Re-grade perimeter
Concrete curbing
Heating and exhaust
LED lighting

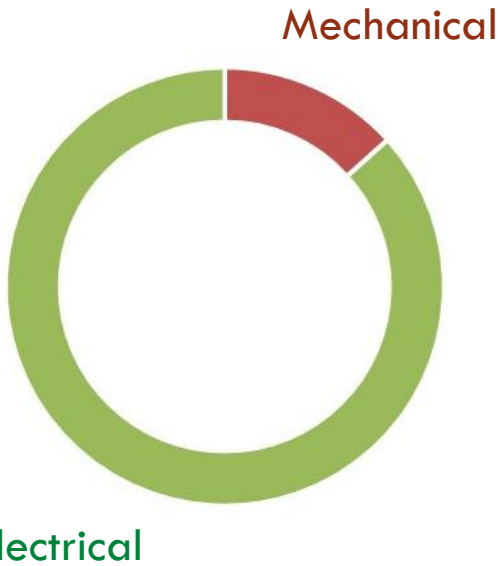
Intermediate
5-10 years

Furnace
Service panels
Lighting controls
Fire alarm panel
Camera system

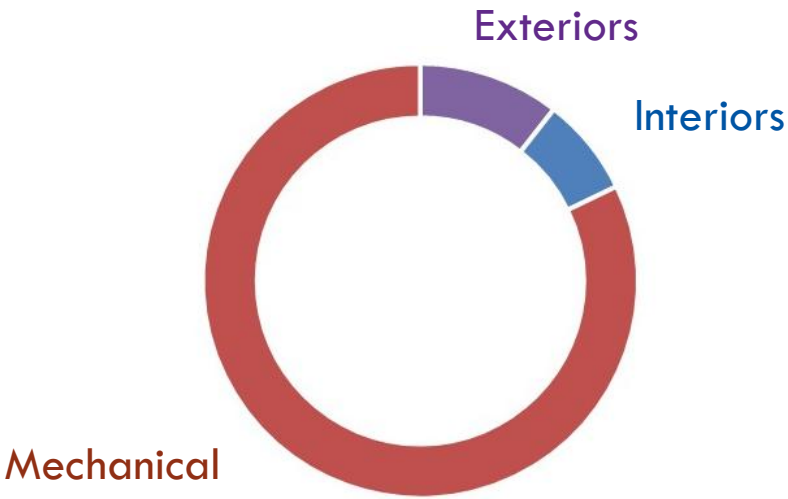
Long Term
10-20 years

Repair paving
Repair concrete slab cracking
Trench drains
Sand interceptor
Air compressor

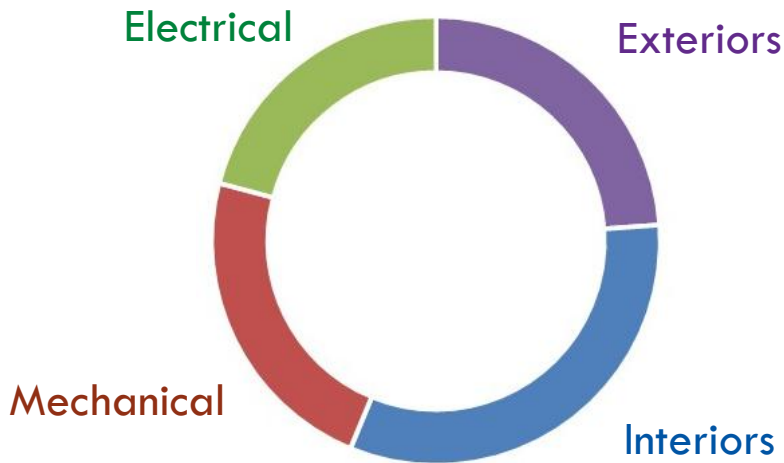
Immediate
0-4 years

- Paint
- Sealant
- Guard at roof hatch
- Concrete slab repairs
- Trench drain grate
- Heating/exhaust fans
- Lighting controls

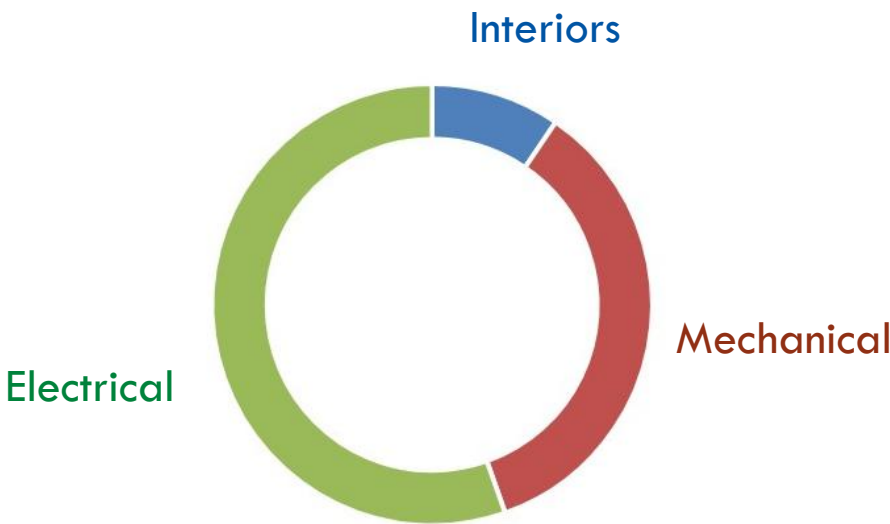
Intermediate
5-10 years

- Concrete slab
- Furnace
- LED light fixtures
- Service panels

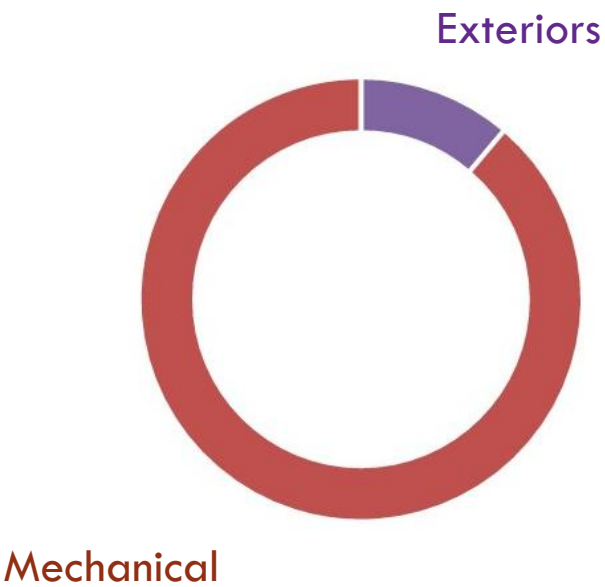
Long Term
10-20 years

- Paving repairs
- Trench drains
- Sand interceptor
- Air compressor
- Plumbing fixtures
