# Technical Memorandum

**Subject:** Goodhue CD1 Tile Inspection and Ditch  
Repair Report

**Project:** HEI 6400-0004

# GOODHUE COUNTY DITCH 1 REPAIR REPORT

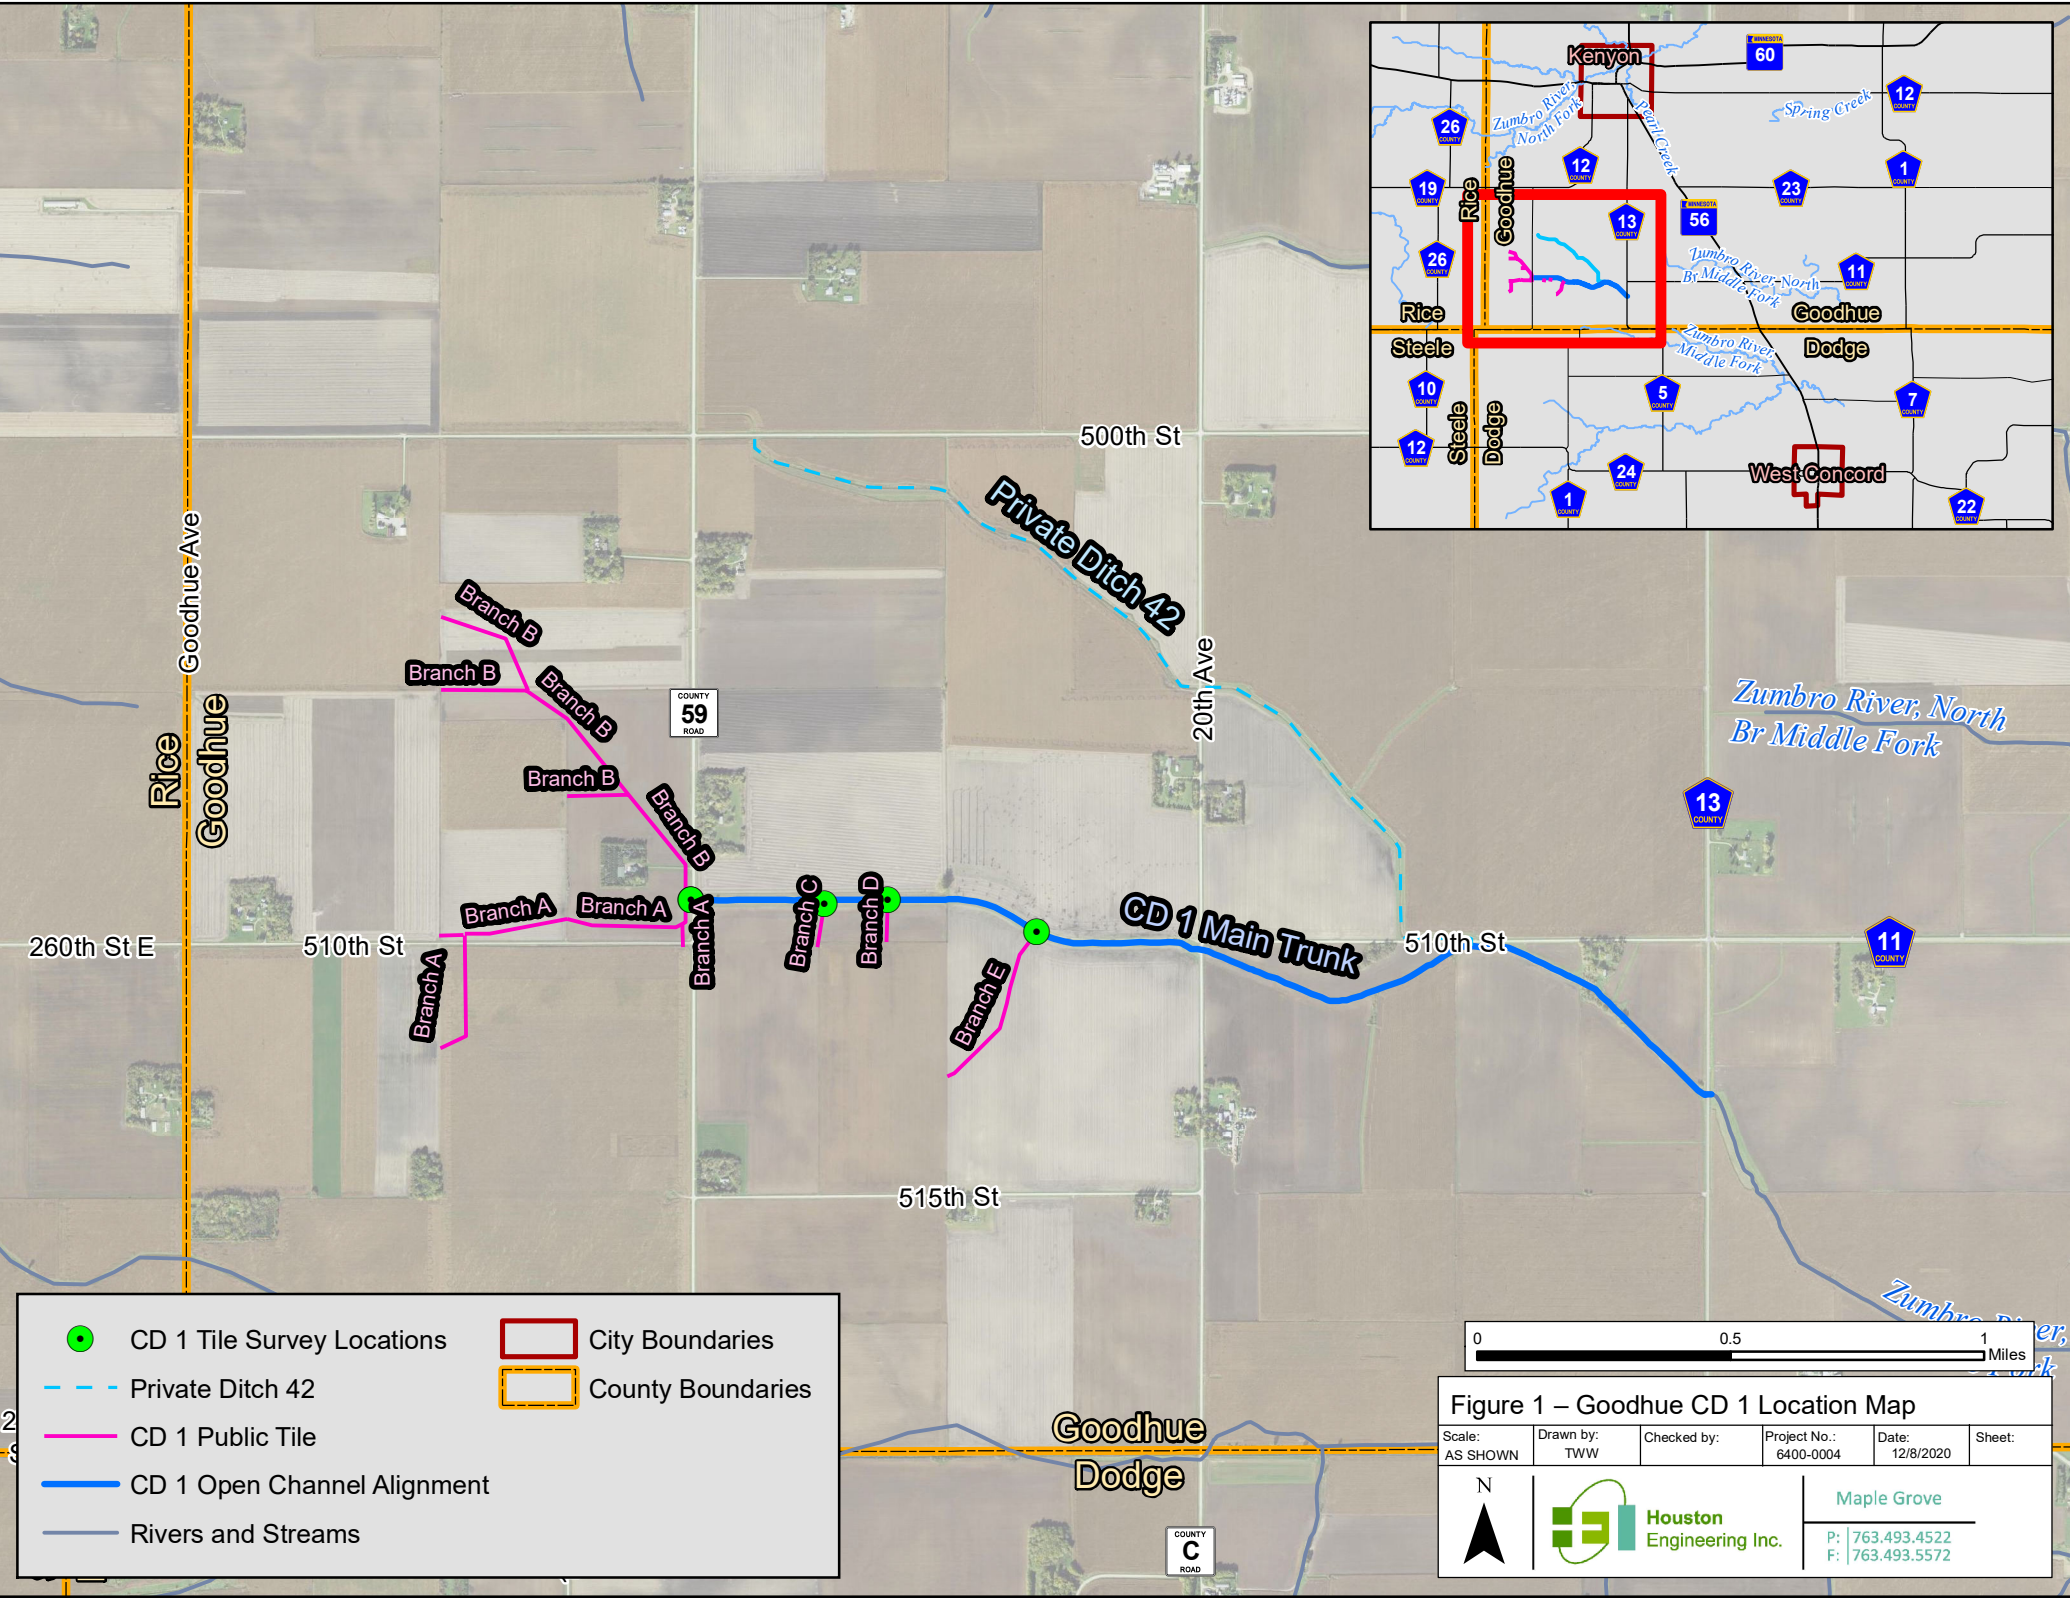
In order to evaluate the condition of the existing system, portions of the tile system were televised in September 2020 by Empire Pipe Services under the supervision of Houston Engineering staff. Televising began at the downstream end of each tile branch where they outlet into the open ditch. The locations are shown on **Figure 1**.

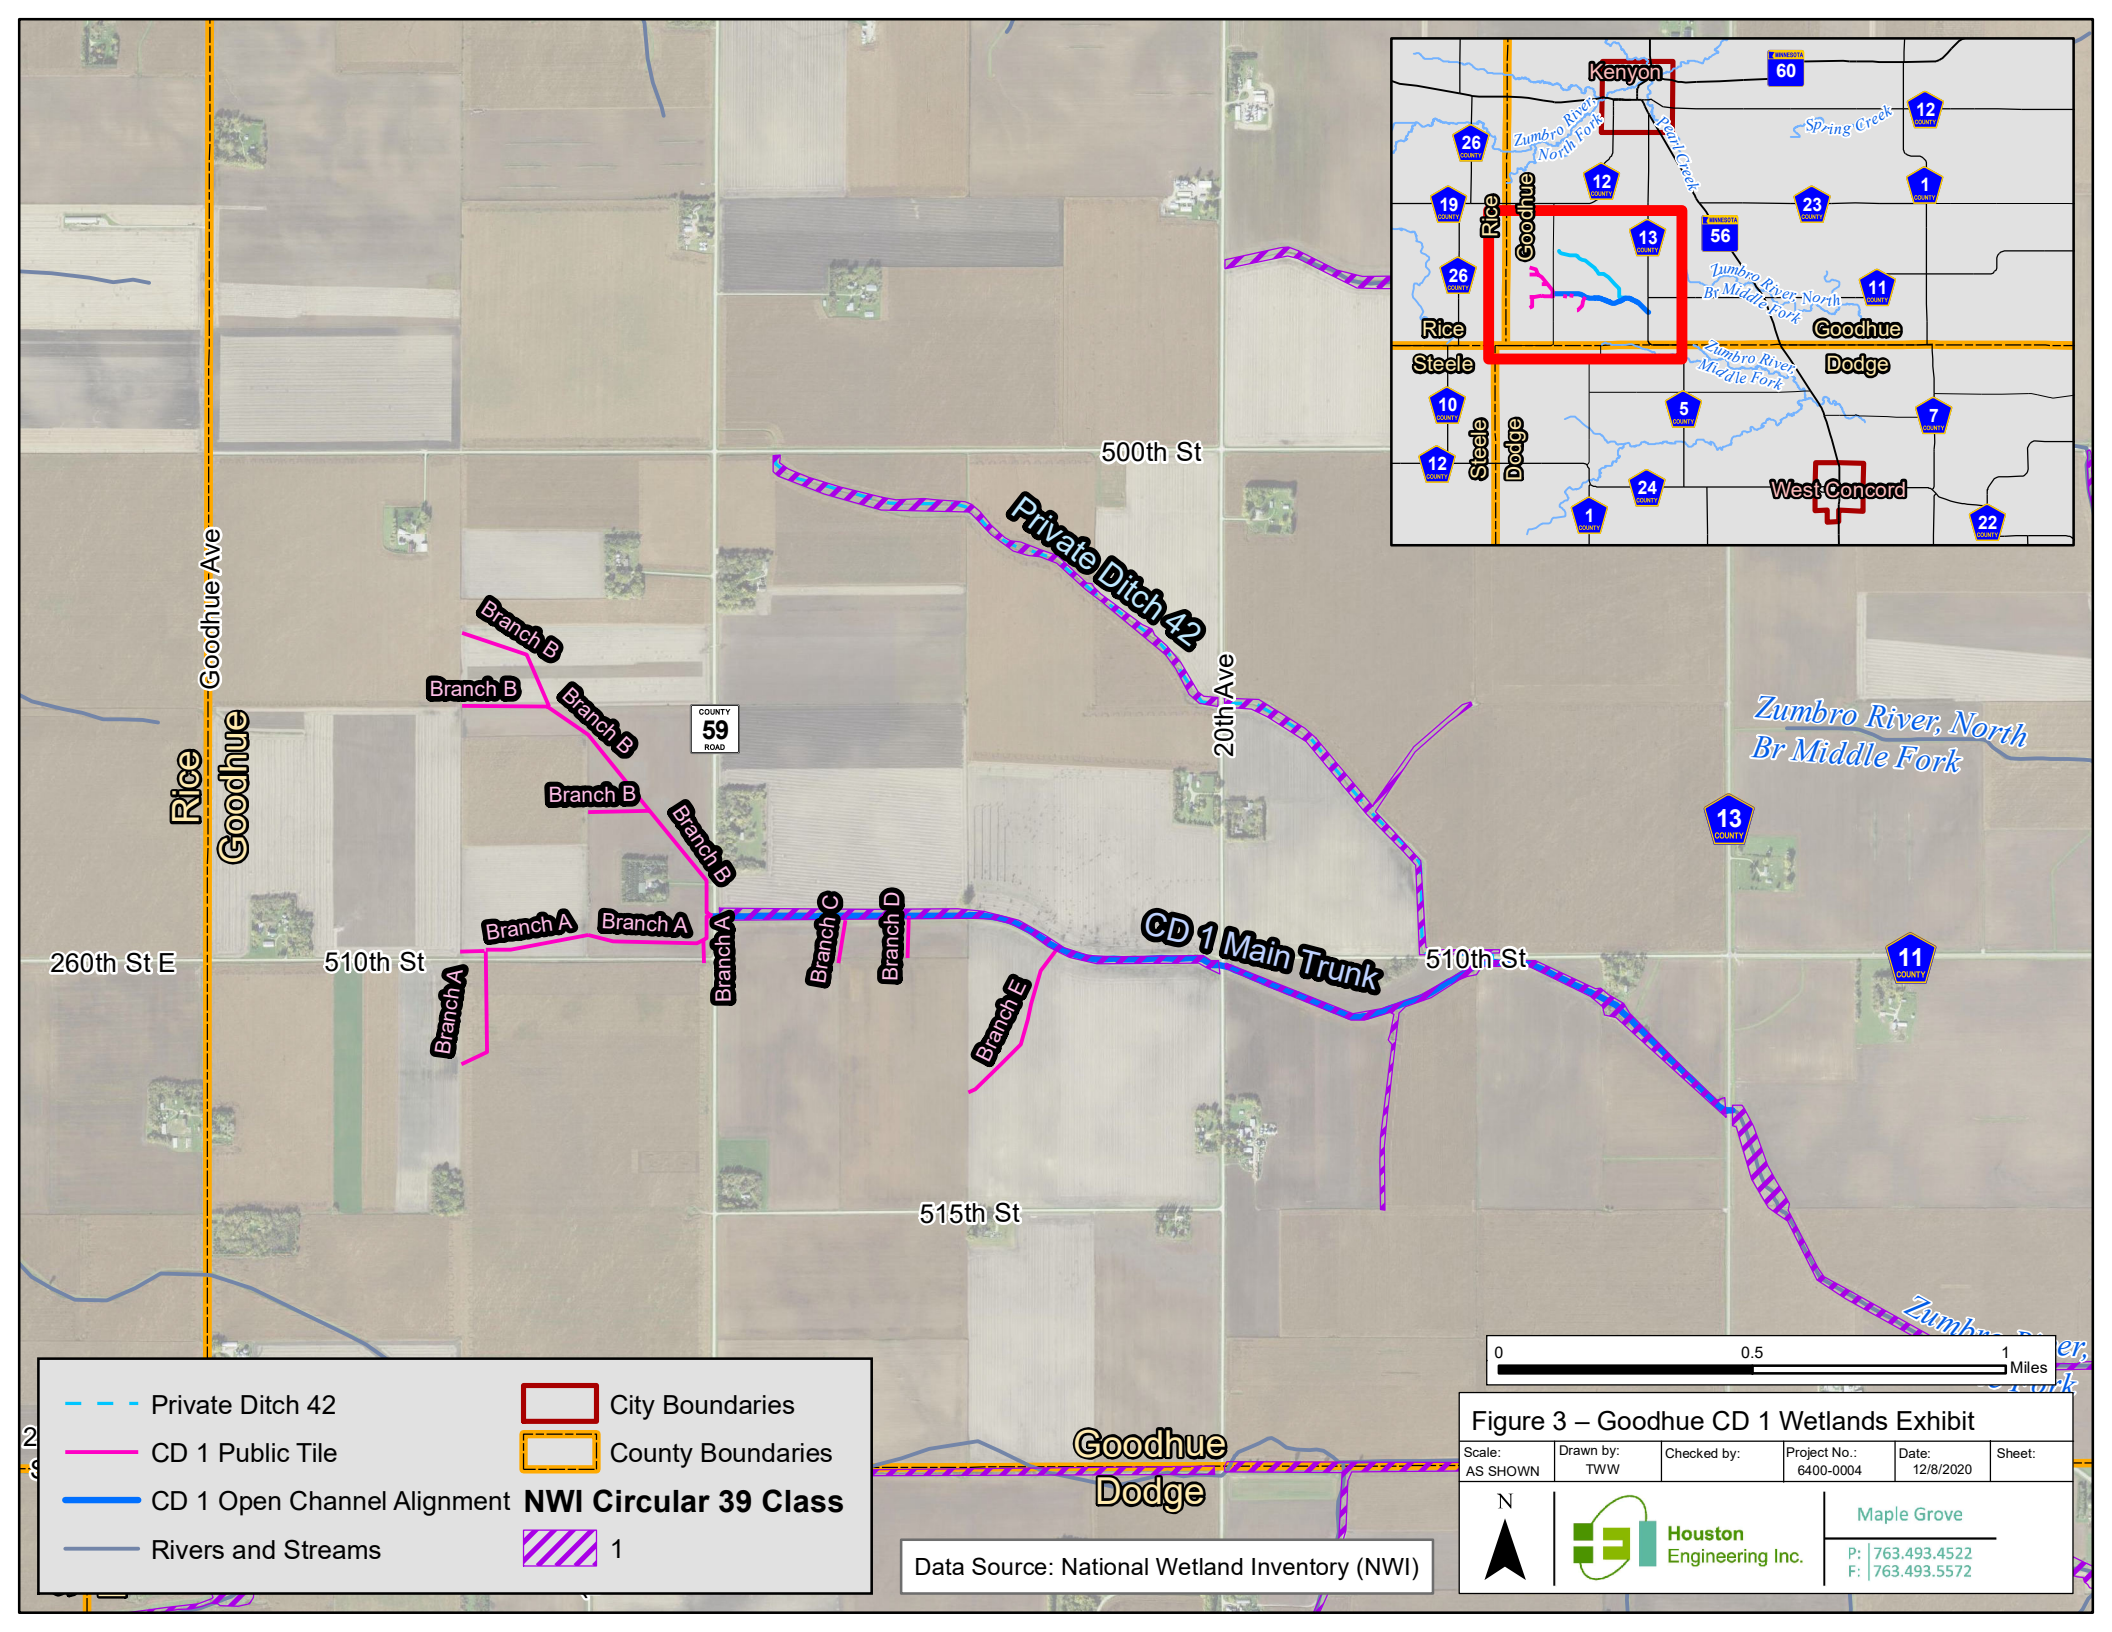
The CD 1 public drainage system intersects wetlands identified in the MnDNR National Wetland Inventory (NWI) as shown in **Figure 3**. Under the two wetland regulatory programs, (Minnesota WCA and Federal CWA) activities related to repair of a public drainage system are generally exempt from permitting and mitigation requirements. These activities related to public drainage system maintenance and repair, and include:

Based on a review of the NWI data and aerial photography to confirm wetland types, the wetlands identified within proximity to CD 1 are Type 1 wetlands (Figure 3). There do not appear to be any Type 3, 4, or 5 wetlands within the CD 1 area, therefore the drainage system repair project will meet the exemption criteria of the state WCA and no wetland permitting is required.
